# Crossway Trails Condition Report

SEPTEMBER 2024

Through the “Data Bike” project, MACOG produced a regional trails condition report. Data collection began in 2023 and was completed in the summer of 2024. We surveyed all 100+ miles of multi-use trails in the four counties. The data was converted into roughness scores and visualized in a map showing the conditions of each trail.

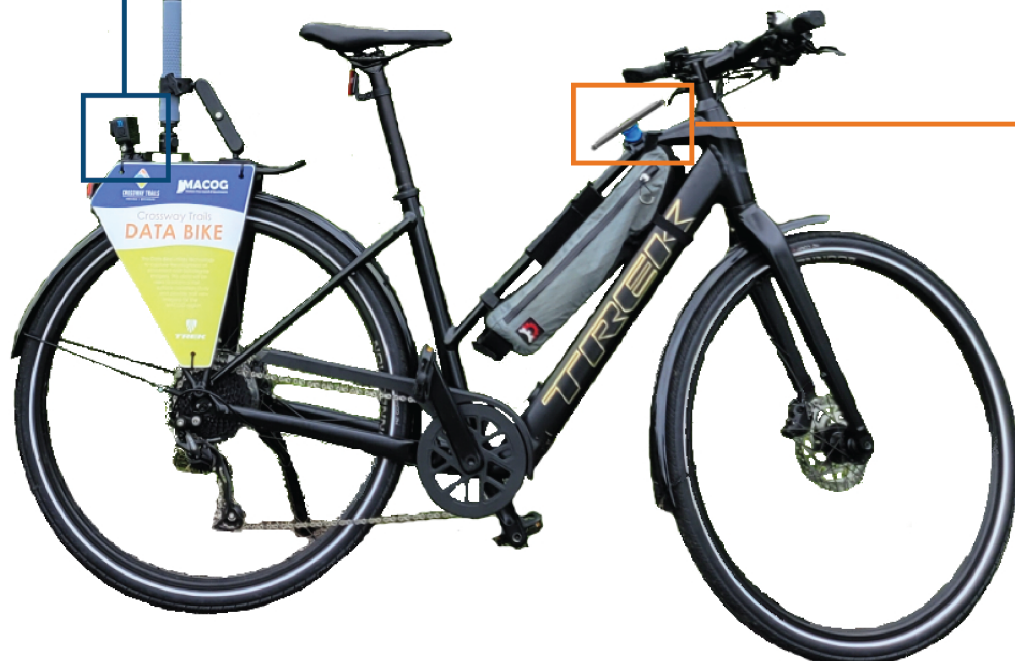
## Data Bike Overview

### 360 Camera:

Provides images of the area surrounding trails. Useful for keeping track of trail conditions other than path surface: low overhanging trees, trail-side amenities and landscaping. Images are uploaded to Google street-view.

### Trek Electric Bike:

Used to maintain a constant speed necessary for accurate surface readings.

### Smartphone Running rRuf App:

rRuf is a smartphone application that utilizes the phone's internal accelerometer and gyroscope as well as vertical displacement to create a map of trail surface conditions based on the trail's Trail Roughness Index (TRI) Score.

### Trail Camera:

Geo-located images are recorded in tandem with trail-roughness readings to create an image-based map of trail conditions.

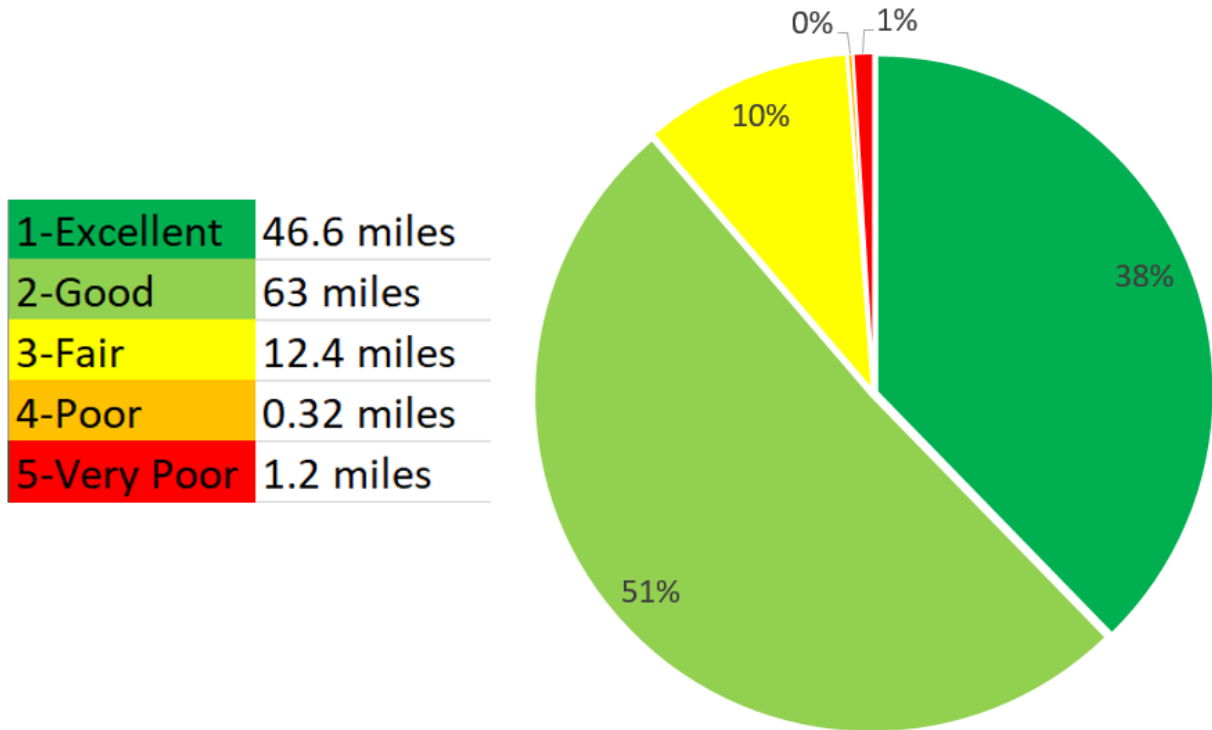
## Overall Path Conditions

**MACOG surveyed over 120 miles of trails, finding that 88% were in excellent or good conditions, with 12% being fair to very poor, highlighting a potential need for maintenance or reconstruction.** To pinpoint specific trail areas needing repairs, each trail was divided into 18-foot intervals. Surveying smaller segments reduces the likelihood that large sections in good condition will obscure areas in disrepair when averaged.

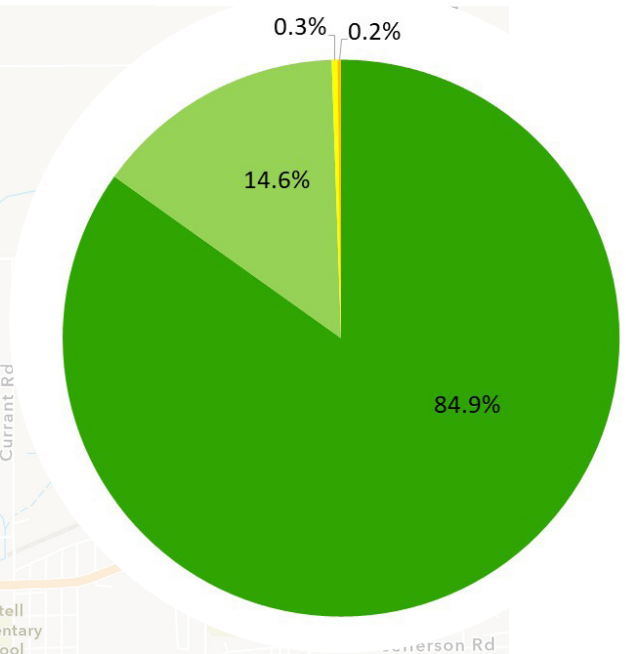
# CAPITAL AVENUE TRAIL

MILES BY CONDITION

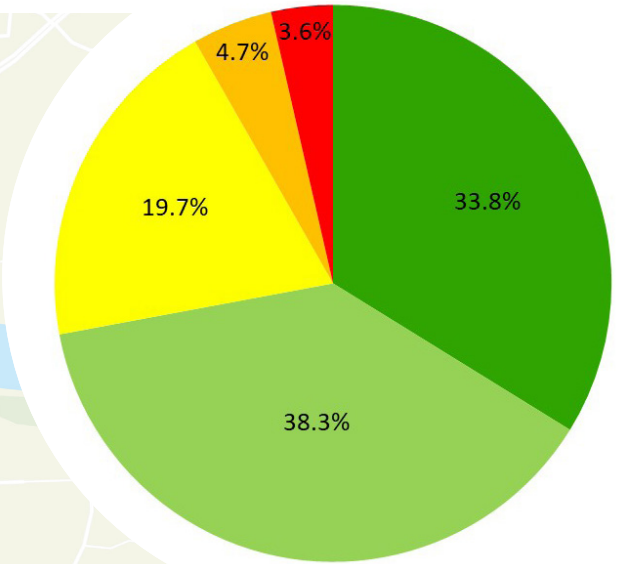
# EASTBANK TRAIL

## AREAS OF MOST CONCERN

Eastbank Trail (Michigan St Bridge)

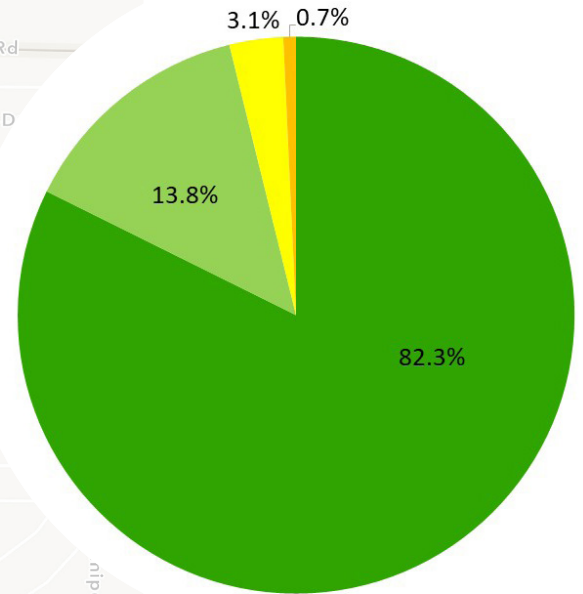
# LASALLE TRAIL

## AREAS OF MOST CONCERN

LaSalle Trail by Dublin Village

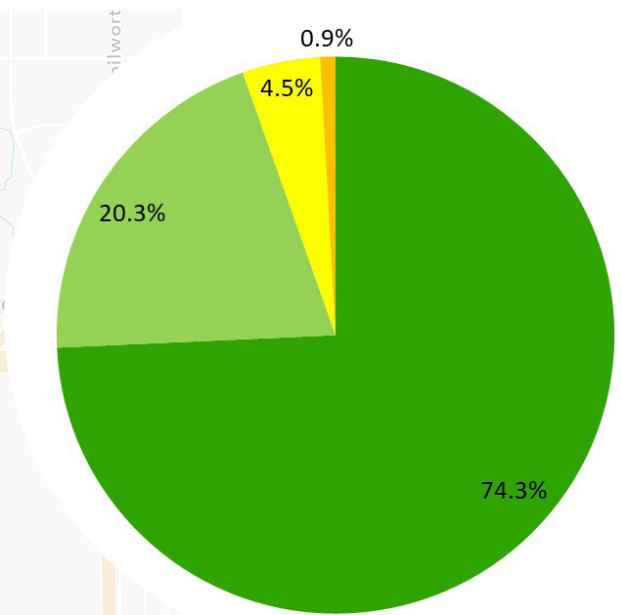
# RIVERSIDE TRAIL

### AREAS OF MOST CONCERN

Riverside Trail at Joyce

Riverside Trail at Pinhook Park

Riverside Trail at Riverside North Apts.
